WATER POLLUTION SURVEY

TOWN CREEK

TOWN OF TIMMINS

1970

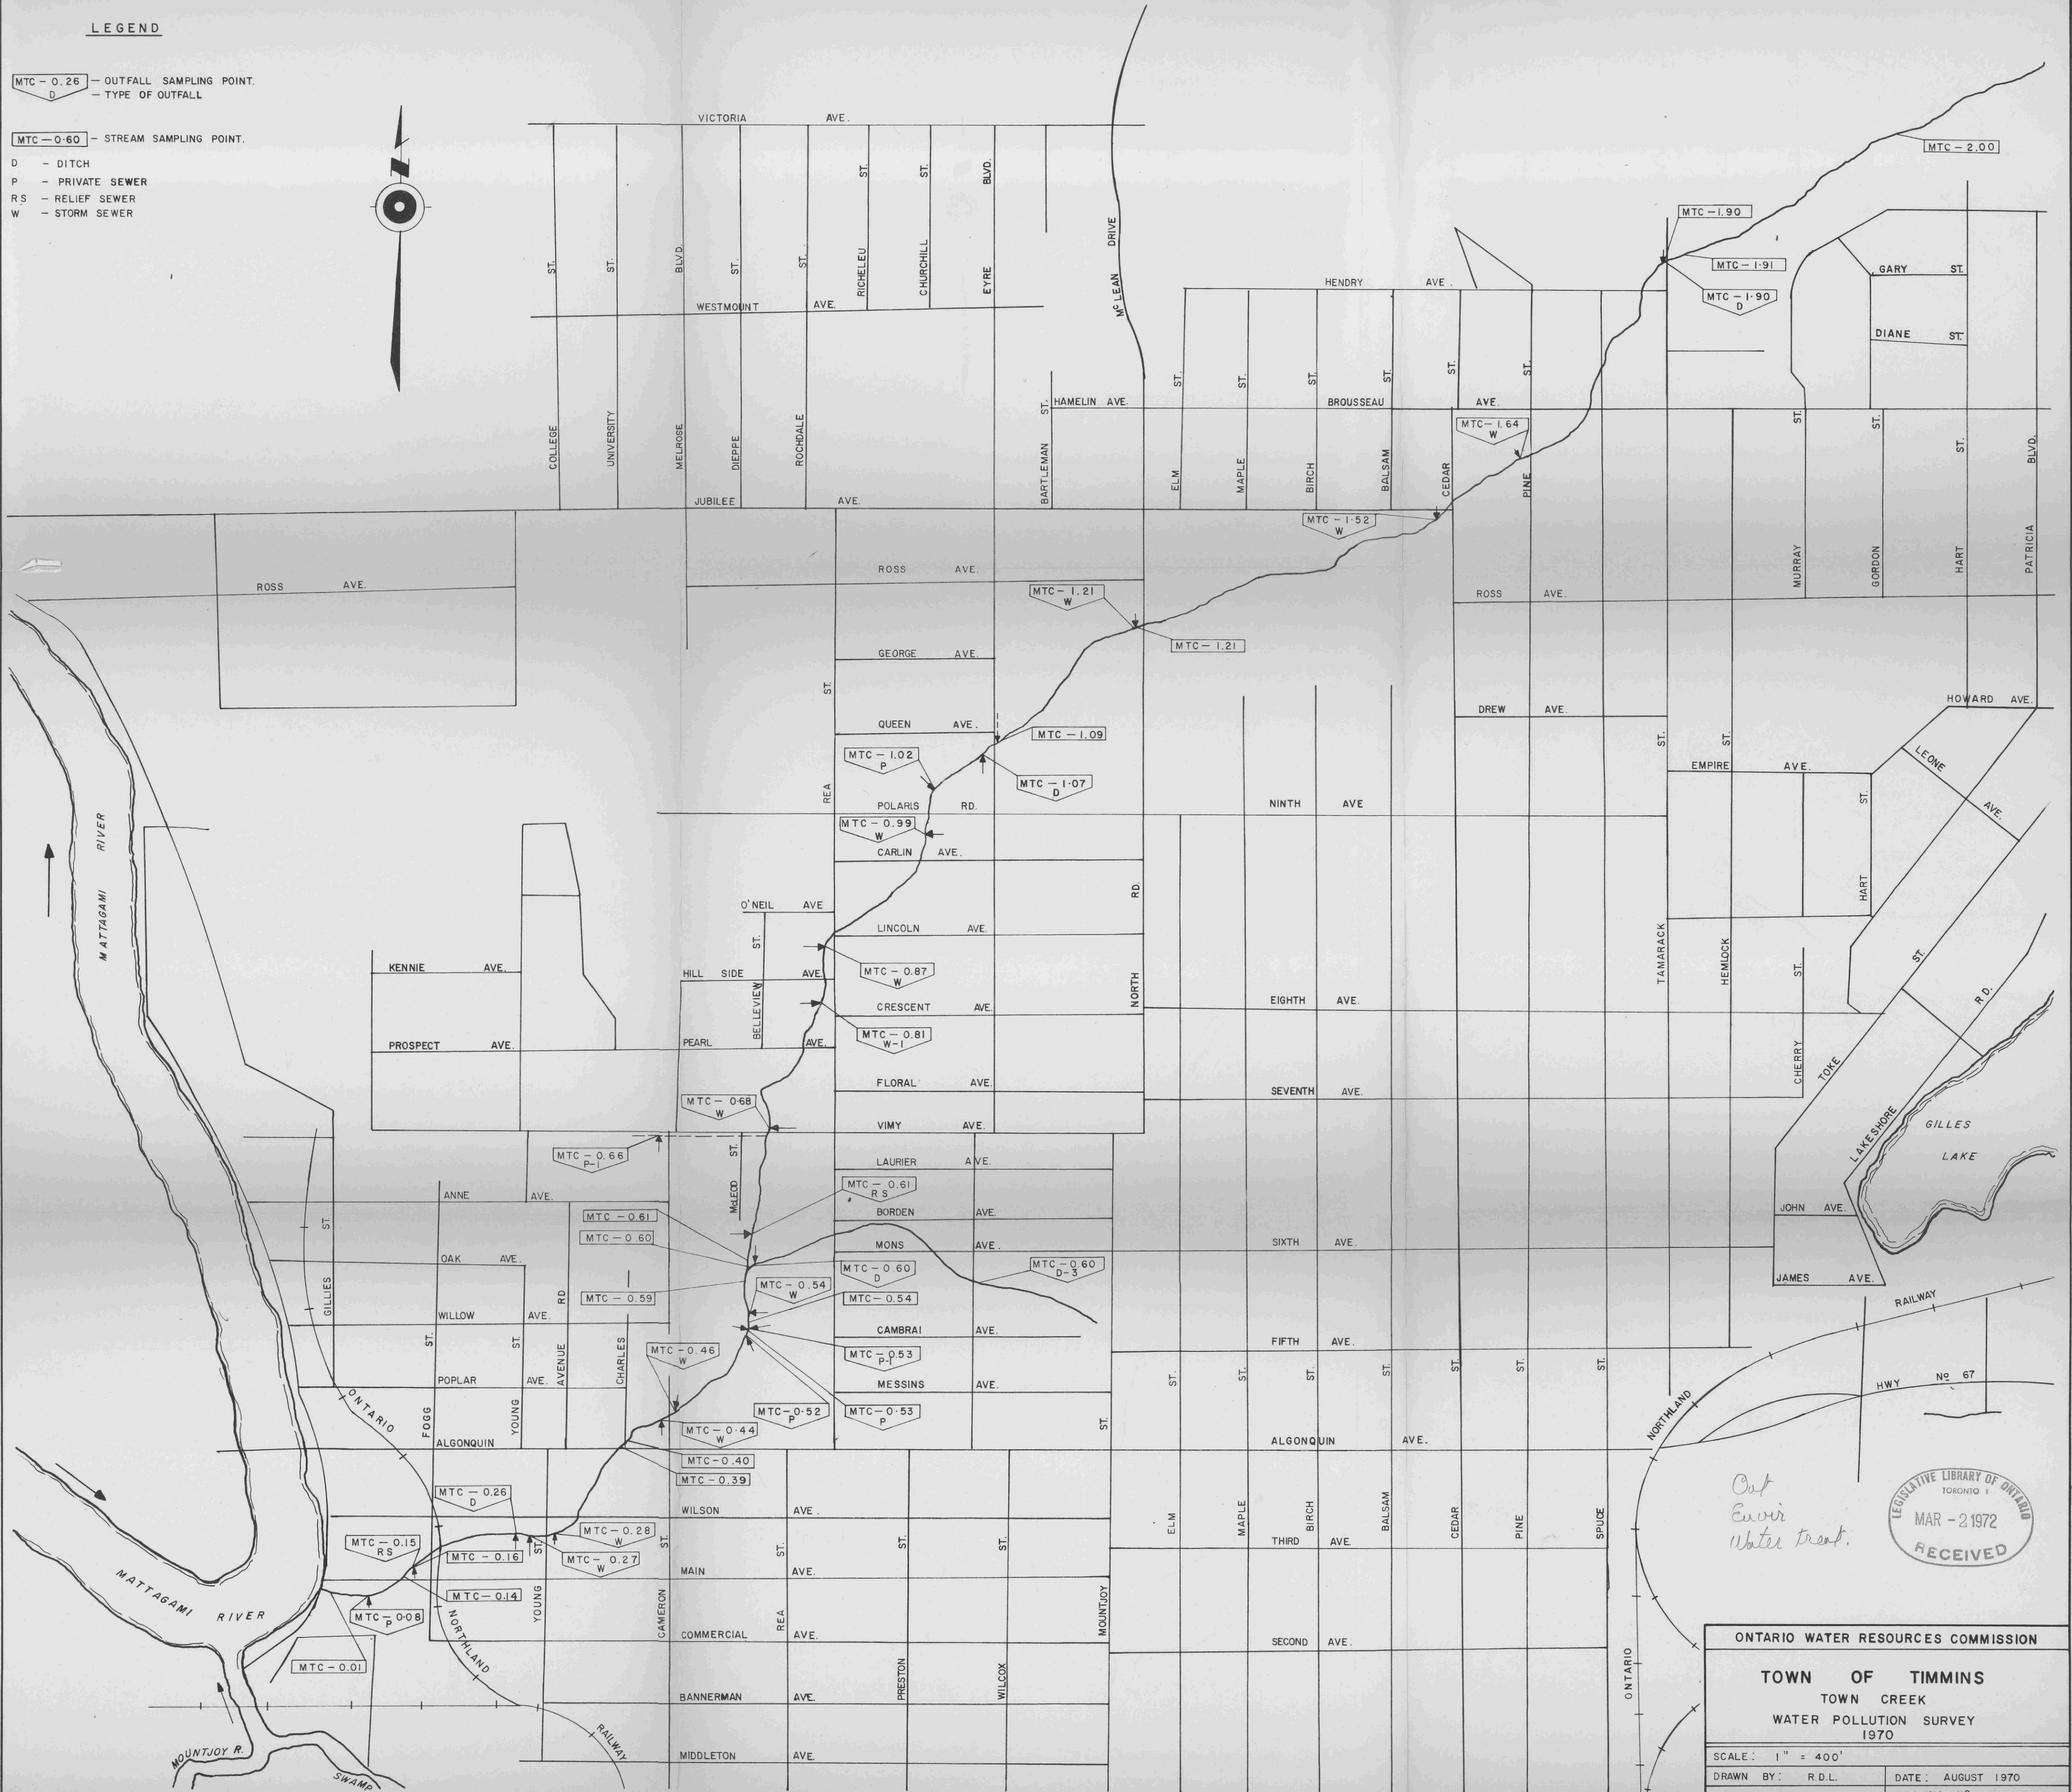
MTC - 0.60 - STREAM SAMPLING POINT.

D - DITCH
P - PRIVATE SEWER
RS - RELIEF SEWER
W - STORM SEWER

- MTC-0.16 - a rapid deterioration of the creek water quality is noted in this vicinity. Coliform counts of a sample showed 260,000 total and 26,000 fecal organisms. Rip-rap has been applied along the banks to this downstream portion of Town Creek in order to prevent erosion. Dye tests were made at homes located at 405 Main Street and 386 Main Street. These tests revealed that raw sewage from these homes (and possibly others), was gaining entry to the creek via an open sewer main on the north side of Main Avenue.

- MTC-0.08P - the effluent discharging from a private sewer drain enters the creek on the south side of Main Avenue. Bacteriological examination of a sample showed coliform counts of 8,000,000+ total and 800,000+ fecal. Such counts indicate the presence of raw sewage. Dye was added into sanitary sewers of homes located at 424 Commercial Street and 386 Main Street. A few minutes later traces of the dye were observed seeping through the stone and concrete rip-rap lining of the creek. It is evident that the open end of a private sewer pipe terminates immediately behind the rip-rap.

- MTC-0.01 - a stream sample was obtained from Town Creek at a point approximately 500 feet upstream from the bank of the Mattagami River. Coliform counts of 130,000 total and 40,000 fecal were determined from a bacteriological examination. It is noted that the polluted contents of Town Creek are discharged to the Mattagami River at a point directly opposite a public bathing beach.

A severed section of a sanitary sewer was noted to be discharging raw sewage to Town Creek at location MTC-0.15RS.
